Manhole Inspection Summary

Manhole # S17M__023MH

Location Address: **2473 ashton-frederick shopping center** Cross Street: **s catherine st**

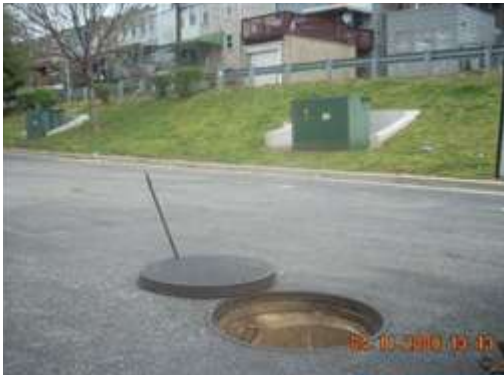
Location View

Comments **delivery area**

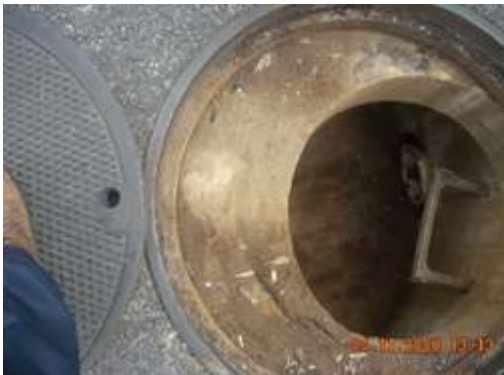
Defect 1

Frame Offset: **7** (in.) Condition: ☒ Sound ☐ Cracked ☐ Leaks

frame offset/ 24 inch entry with a 30 inch lid

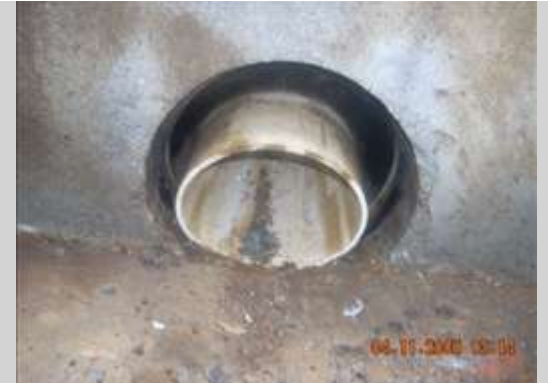
12 O'Clock Outflow

8 in. Circular Gravity Sewer
Pipe Out @ 12 O'Clock

Pipe Height: **8.4** (in.) Rod and Bar (Angled)

Pipe Material: **PVC** ☐ Pipe Lined

Invert Depth: **3.25** (ft.) Flow Characteristics: **None**

Infiltration: **None** Pipe Seal Cond: **Unknown**
